Our Ideas for the Future

Installation details

- Location: TDK Dalian Electronics | www.jp.tdk.com
Model/Area:

Vulcan S10 effect verification

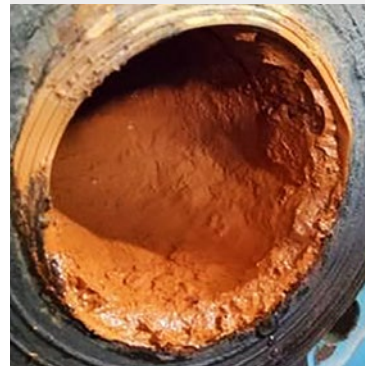
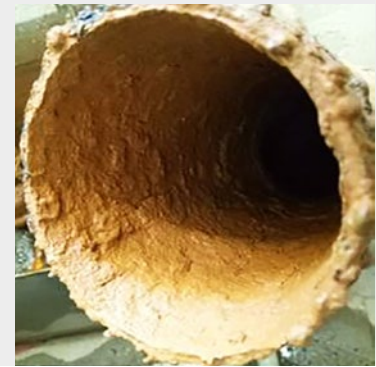
Before Vulcan

The pipe had been used for 15 years and had a very thick hard scale layer inside. The pipe was not cleaned before Vulcan S10 was installed. The following two photos are the observation points selected before Vulcan installation.

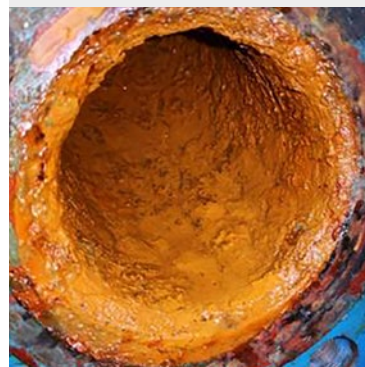
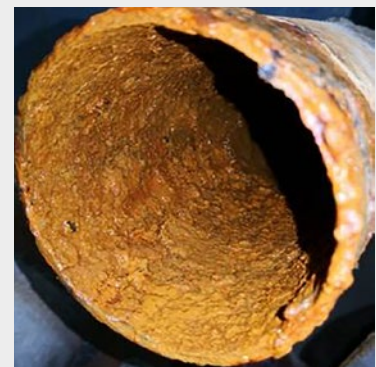
After Vulcan S10 was installed for 4 months

The scales inside the pipe have been gradually reduced, and they do not fall off in blocks, which will not affect the operation of pumps and other equipment. Because of the good results, the customer decides to apply Vulcan in several other cooling systems.

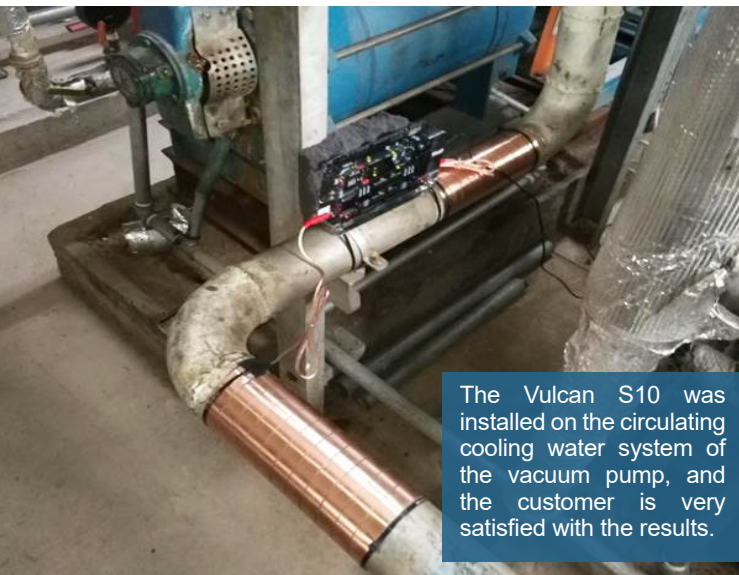
The Vulcan S10 was installed on the circulating cooling water system of the vacuum pump, and the customer is very satisfied with the results.

**Vulcan S10** x 1 for circulating cooling system of the vacuum pump
