Installation Details

Location: Chrysler transmission plant
in Kokomo, Indiana
www.chrysler.com

Area: High pressure wash station

Installed by: Salt-Free Water Systems LLC

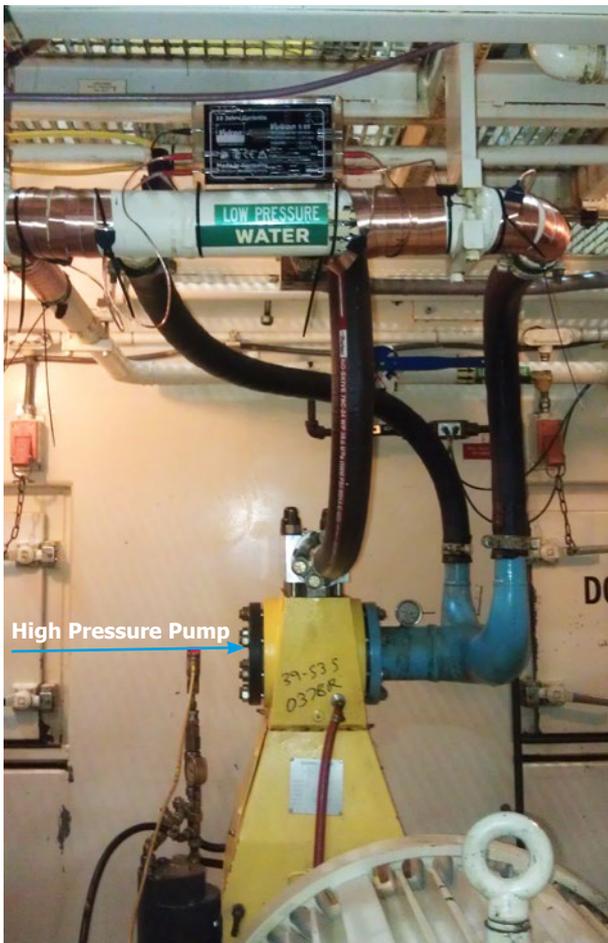
Vulcan S25 was installed on the high pressure
wash station in the Chrysler ITP 2 plant.

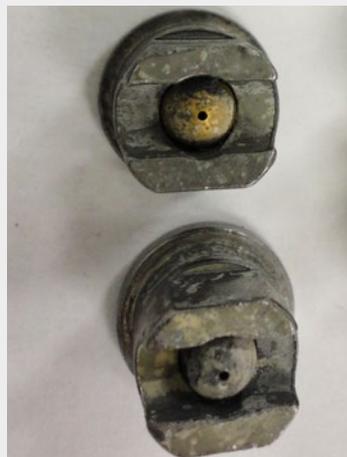
Screen and nozzle from high pressure deburr machine indiana transmission plant

After 3 weeks normal
conditions

Before the Vulcan was installed, there would be a
12mm calcium buildup in the nozzle by this time
and they would exchange it with one that had been
acid cleaned.

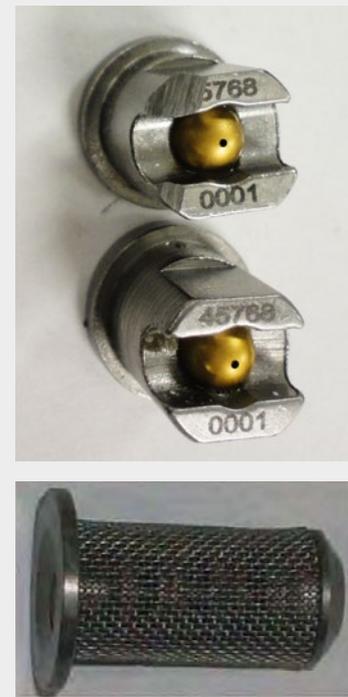
After 3 weeks with
Vulcan S25 installed

Vulcan results: S25 has been installed for 3 weeks.

The maintenance man held the cleaned one in one
hand & the one he had just removed, in the other
hand. He was showing them to an engineer and
held out the cleaned nozzle and said he was going
to install it on the wash station - The engineer said
"Why would you install the dirty nozzle instead of the
clean one!" Everyone was amazed - 35 more Vulcan
S25 were ordered after this test.
